PULLEN AQUATIC CENTER

Innovative Air Dispersion Solutions for Open Ceiling Architecture.

FABRIC DUNKS METAL IN POOL ENVIRONMENT.

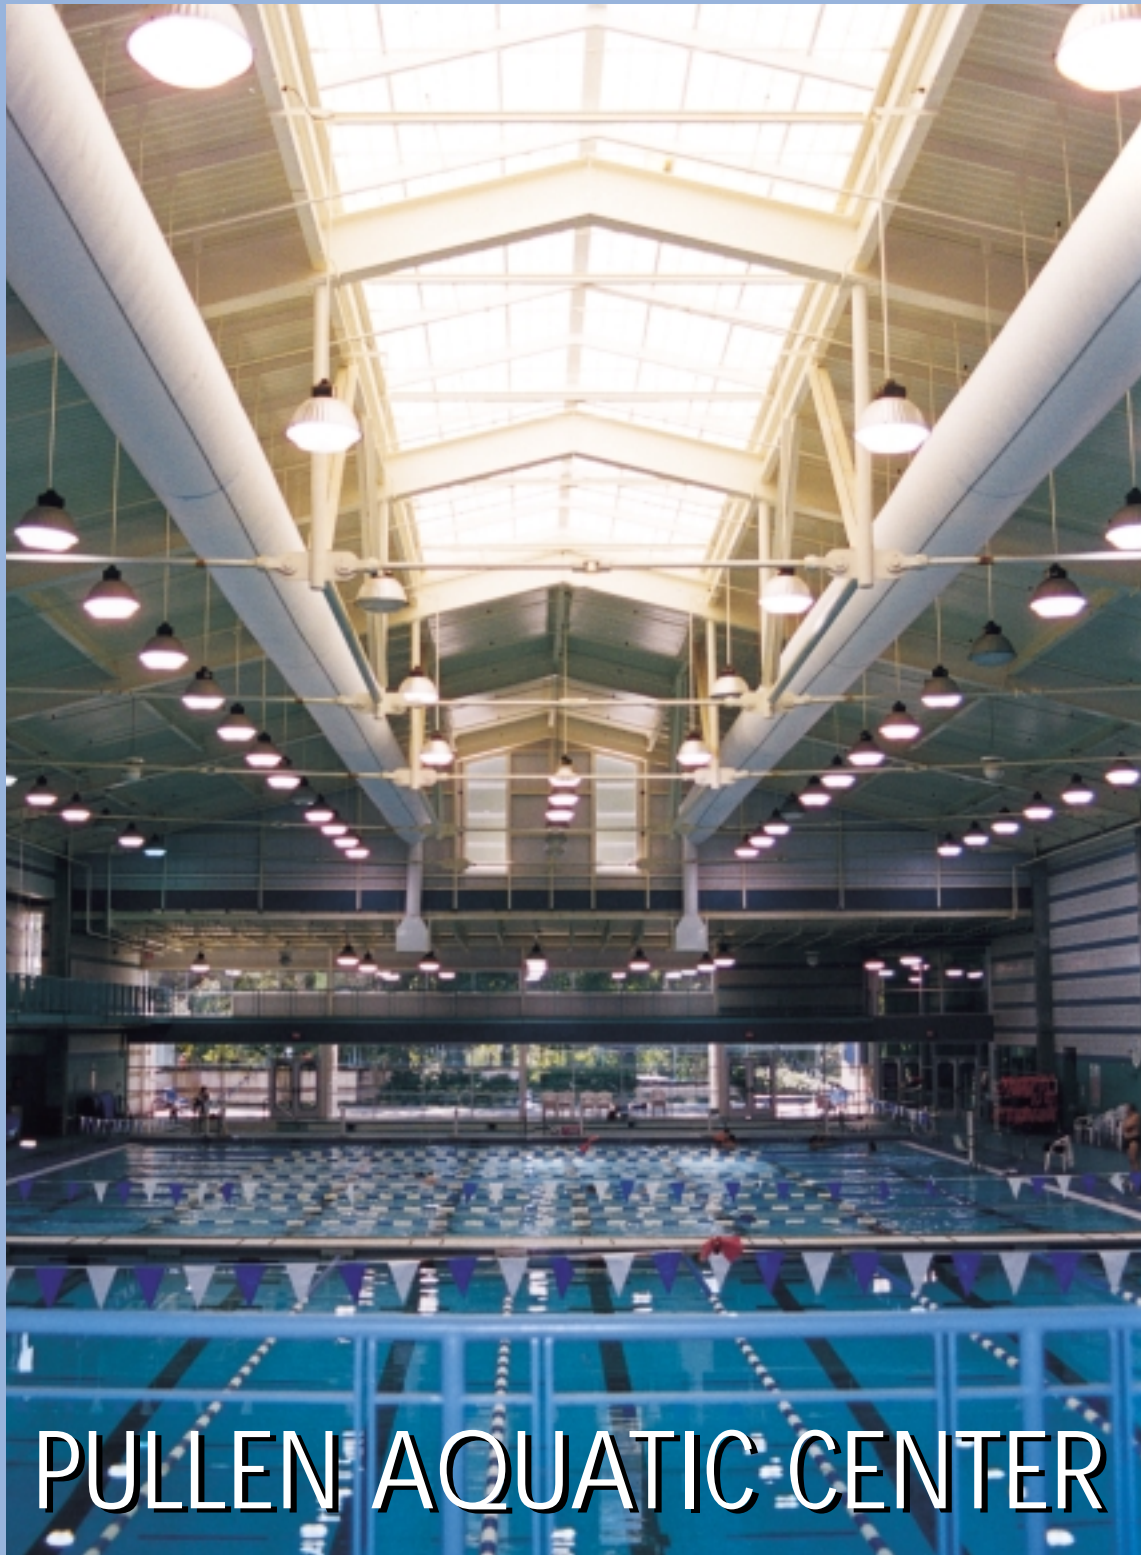
Application features 2 Comfort Flow DuctSox units each 50" in diameter x 161' in length. Each DuctSox diffuses 25,000 CFM at .5 ESP through porous fabric and linear mesh vents 1/2" wide. Vents can be seen in the picture above diffusing air toward pool.

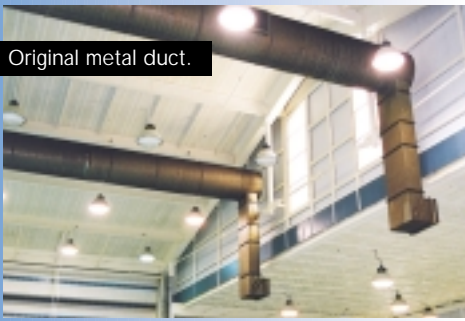
Original metal duct.

Only six years after the city of Raleigh North Carolina built *Pullen*, the rust flakes falling from stainless steel ceiling ducts made a shutdown and complete duct removal necessary. "Every morning we would have more flakes in the pool," recalled Terri Stroupe, Aquatic Facilities Supervisor at the center. "It builds up. We had to polish the pool and the deck frequently just to keep the tile from staining red."

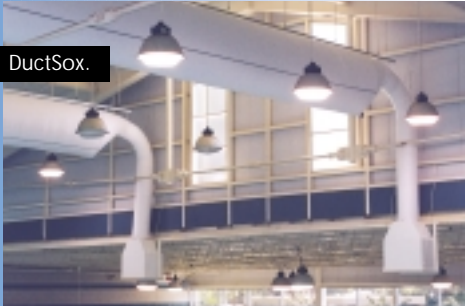
DuctSox.

The problem was solved by replacing the old network of ducts with a new Comfort Flow DuctSox fabric air dispersion system. The porous polyester fabric construction of DuctSox is virtually unaffected by pool chemicals in the air, which corroded the original stainless steel. Even though a recreational pool doesn't seem like a chemically hazardous environment, it can be torturous to metal of all types. "We have to work on our railings constantly to keep the rust down," said Stroupe. "In a chlorine environment, you need something resistant like the fabric of the DuctSox."

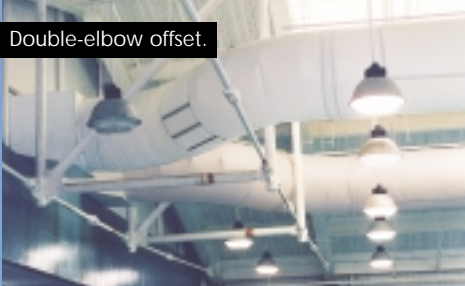
Double-elbow offset.

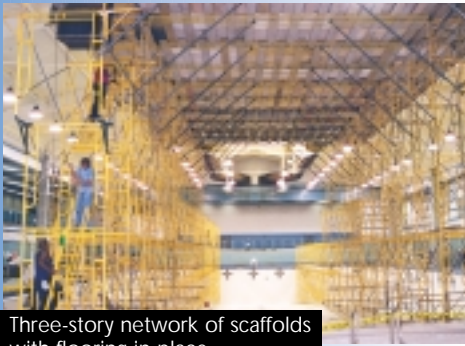
Three-story network of scaffolds with flooring in place.

A two-story network of scaffolds was needed to enclose most of the building's exposed ceiling before beginning the three-week process of cutting down and hauling out the rusted metal. By contrast, the bulk of the DuctSox installation was completed in two days.

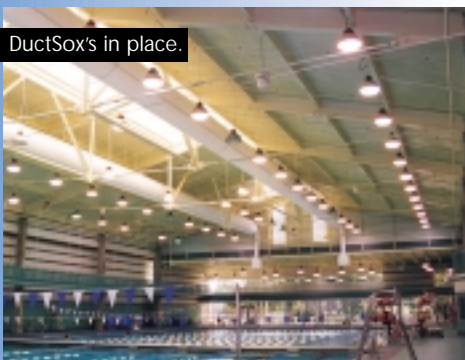
DuctSox's in place.
